FRAME INSPECTION

123 Dream Street
Missouri City, TX 77459
Invoice No.: Sample Frame Inspection

This is a limited visual inspection of a one story home, approximately 2000 sq. ft.
The house faces south for inspection purposes.
No plans, specifications, or reports were available for inspection

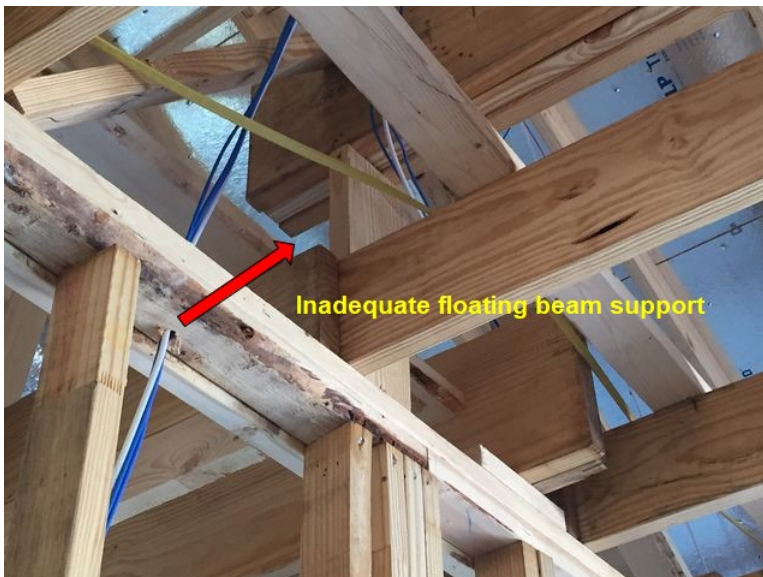
1. There are a few framing issues noted in the house.
 - The floating beam in the living room has not been properly supported. Each beam should have at least one stud or other dimensional structural member underneath it.

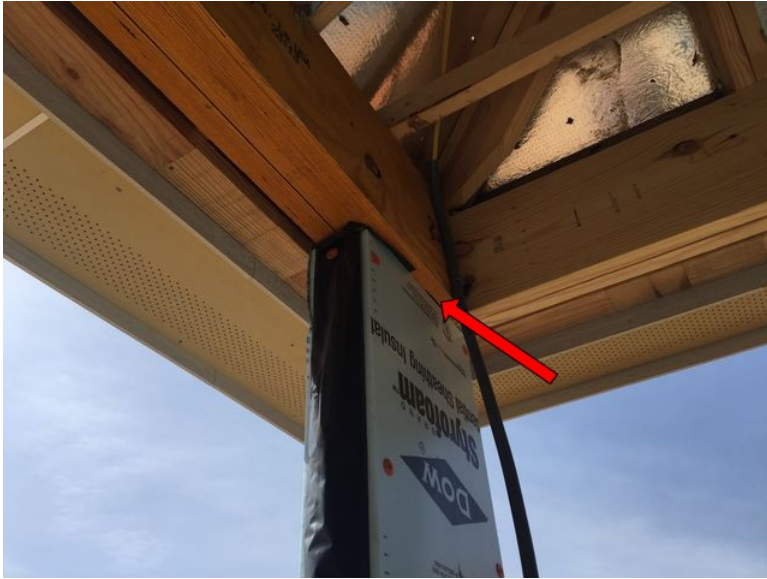
2. The LVL (laminated veneer lumber) on the front porch also is missing vertical support.

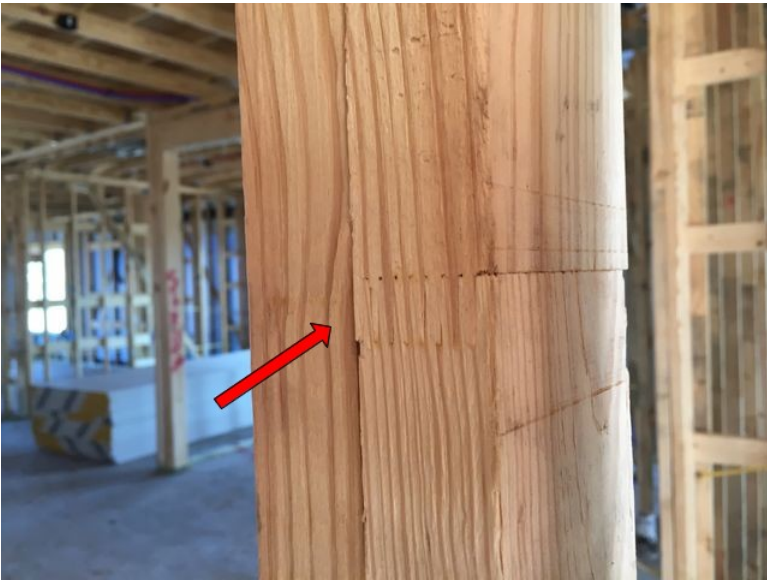
3. It is noted there are finger joints in the house. These are typical in most new construction. They are acceptable for wall studs, as long as they are only for compression and not length spans (horizontal or diagonal).

- They typically are straighter than natural studs.

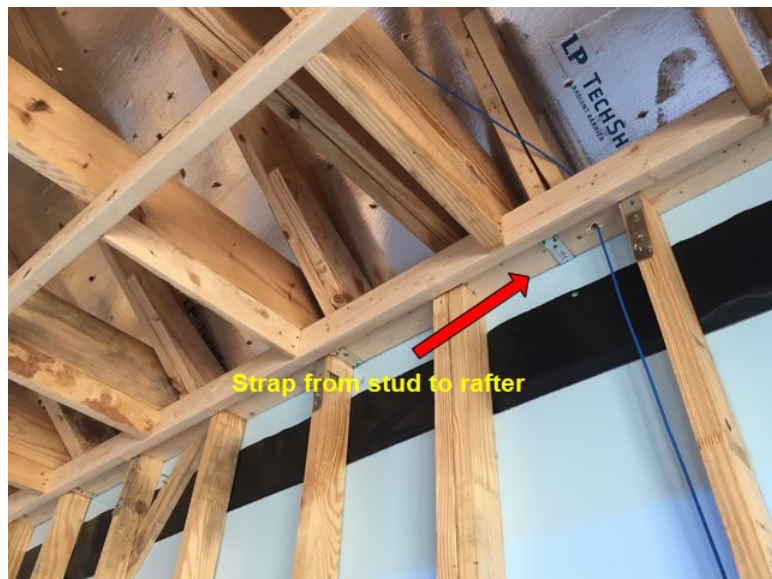
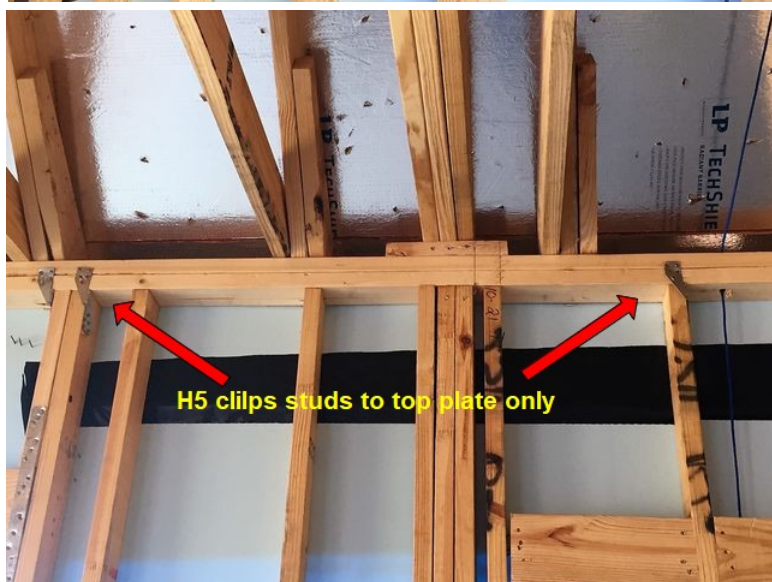
4. Find out about the windstorm engineering. The right side of the house has H5 clips (Sampson), but the left side has linear straps.

- The left side has straps from the wall studs to the rafters, but the right side does not have straps from the studs to the rafters.

- Some of the studs are missing H5 clips; this may be due to repairs made during the framing process.
- The engineer is the authority on what is required for windstorm engineering. Some components that are typical of wind storm engineering include, various framing straps or hurricane clips, sheer walls that are designed to add strength to the interior walls, specific foundation anchors and specific window requirements (among other engineering designs).

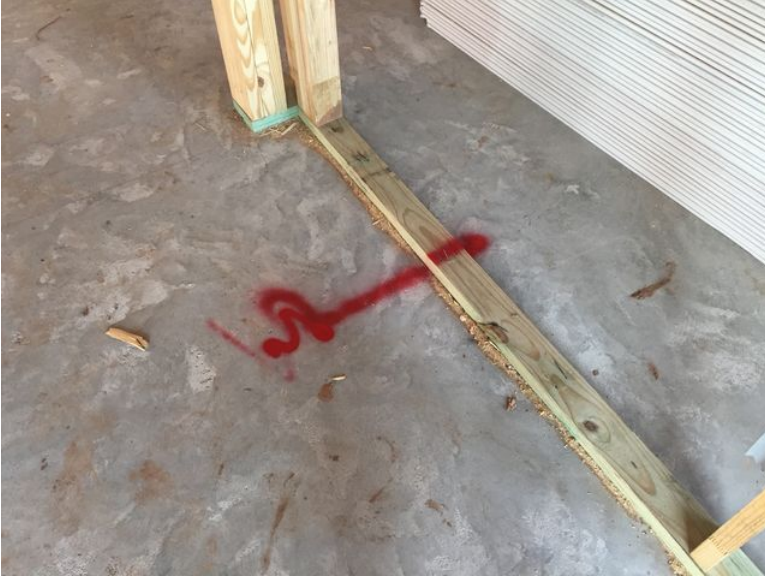
5. The framing is incomplete.

- Dining room is missing studs.

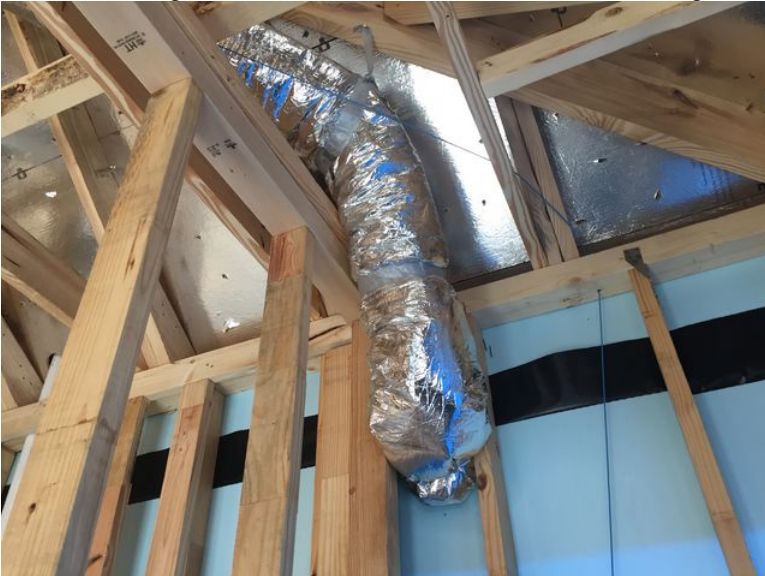
- Chase/furring needed for HVAC fresh air intake in front right closet space.

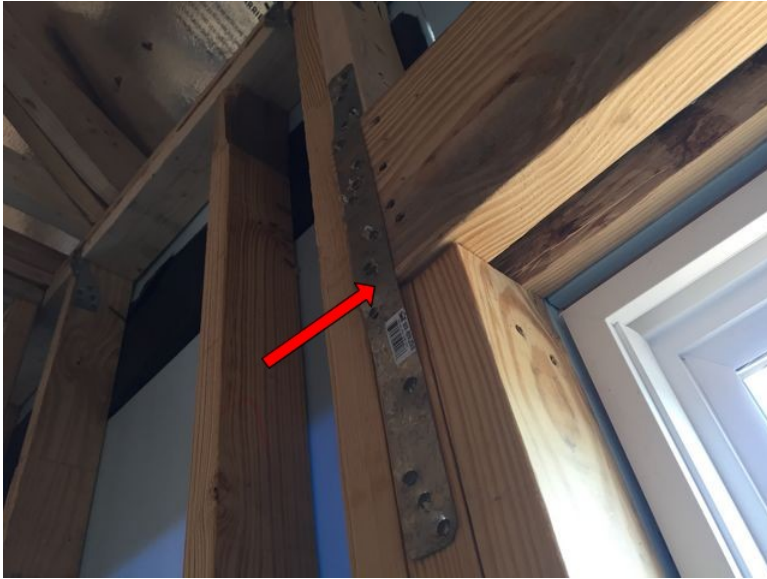
6. Dining room window header is not in plane (sticking out).

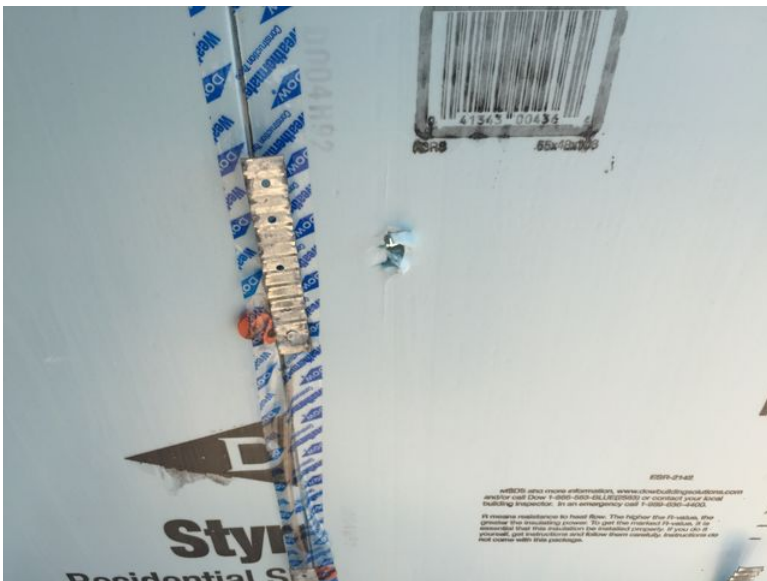
1. There are a few areas on the exterior sheathing that need to be sealed.

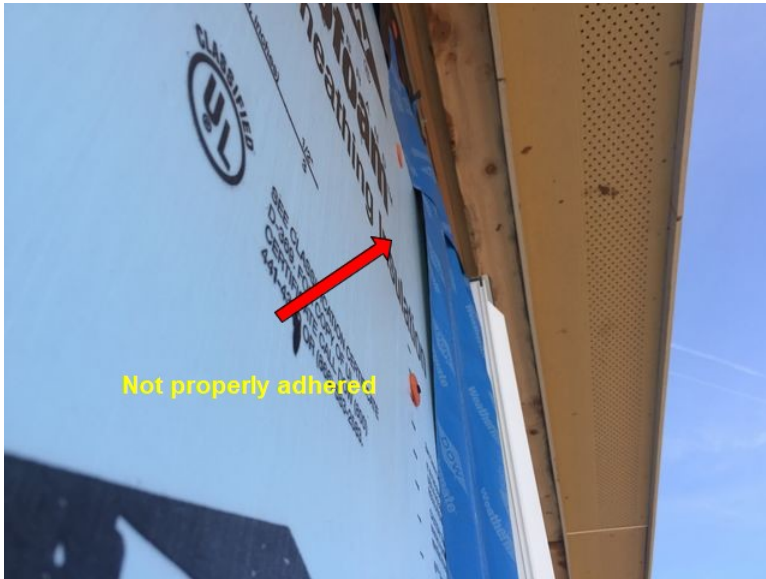
2. The flashing on the windows is not installed properly.

- The butyl rubber flashing tape should be sealed with a j-roller or pressed in place with hands during the installation.

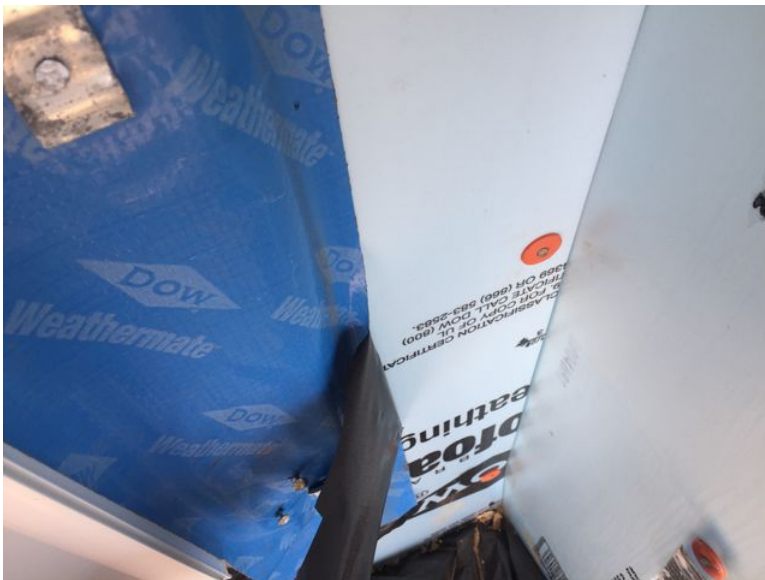
- There is plastic sheathing that was not trimmed prior to butyl rubber flashing installation. This prevents the area from being sealed properly.

This is typically required by the sheathing installer, and will affect the ability of the vapor barrier to function properly.

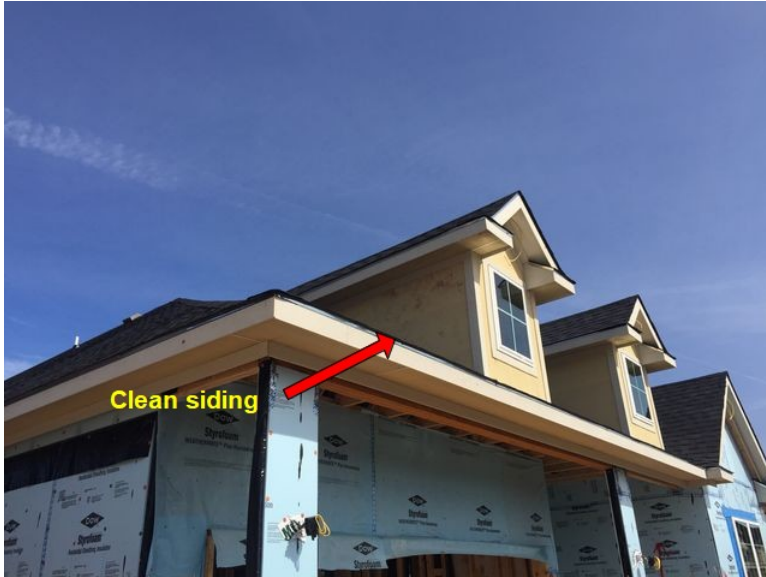
3. The cement fiberboard siding needs to be cleaned prior to painting.

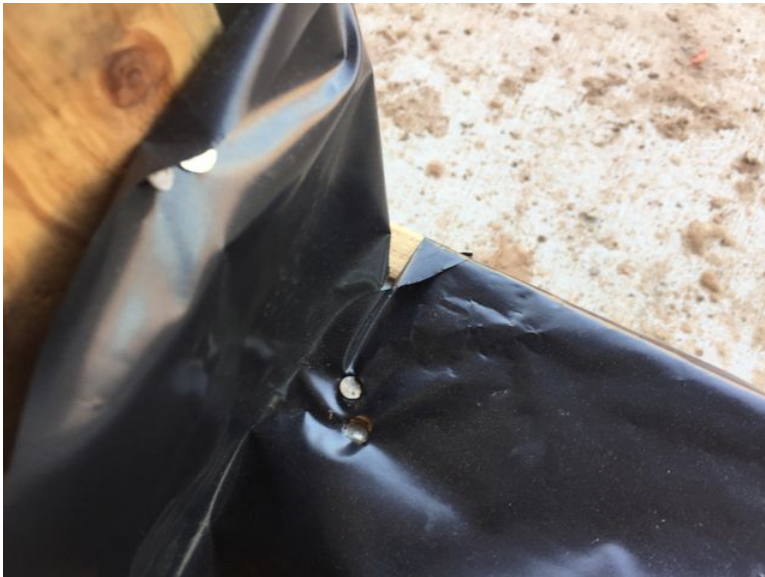
4. Three windows have not been installed in the back of the house.
5. The plastic flashing for the several of the windows has been perforated with nails (or folded over). This defeats the purpose of the flashing to prevent moisture from entering the house. The plastic can be nailed on the exterior and interior to protect the integrity of the window flashing.

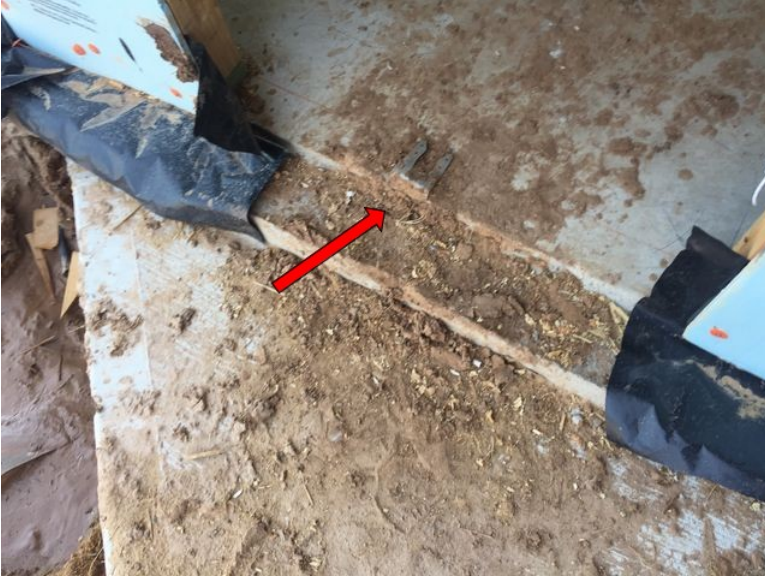
6. Typically, the front, back and garage entry doors are installed prior to the frame inspection.
7. There is a foundation support bracket that needs to be removed prior to the door installation.

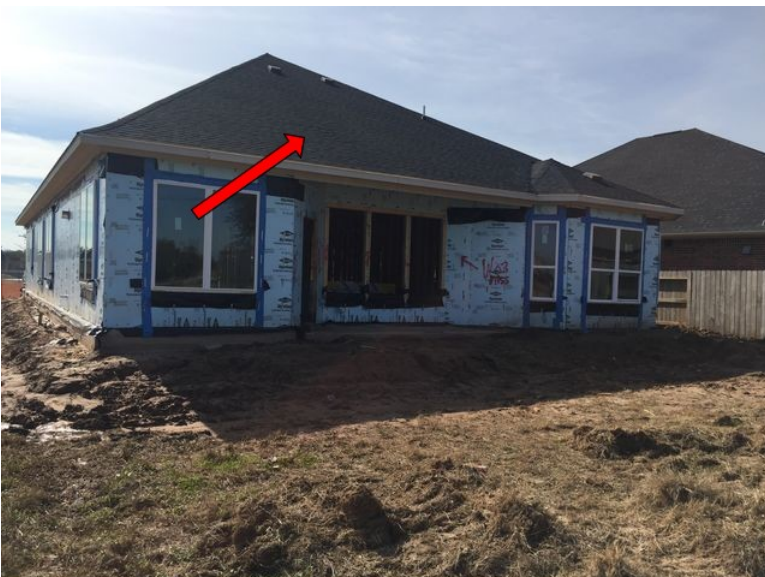
Some lifted shingles noted on the back of the house.

- This will be reviewed at the final inspection. It is not uncommon for there to be some damage from other trades on the roof during construction.

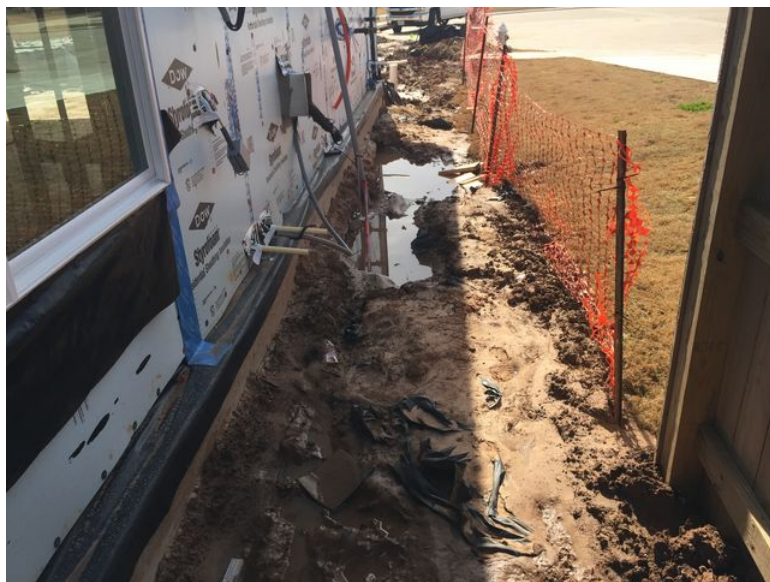
1. It is noted there is a decent rough grade noted on the house. The grading is for a corner lot; the side and part of the back yard drains into the detention pond.
 - The left side of the house is holding water.

- Consider installing an underground drain line in this area as it is a difficult area to drain. This can be done easily during the installation of the sprinkler system.
2. Be sure to discuss the building lines, easements and homeowner association requirements for any additions or improvements.
 3. Many of the tubes in the wall are too close to the edge of the studs. These can be damaged by drywall nails/screws during the construction. Electrical and plumbing lines require metal plates to protect them. This is an ancillary system that is beyond the scope of a home inspection.

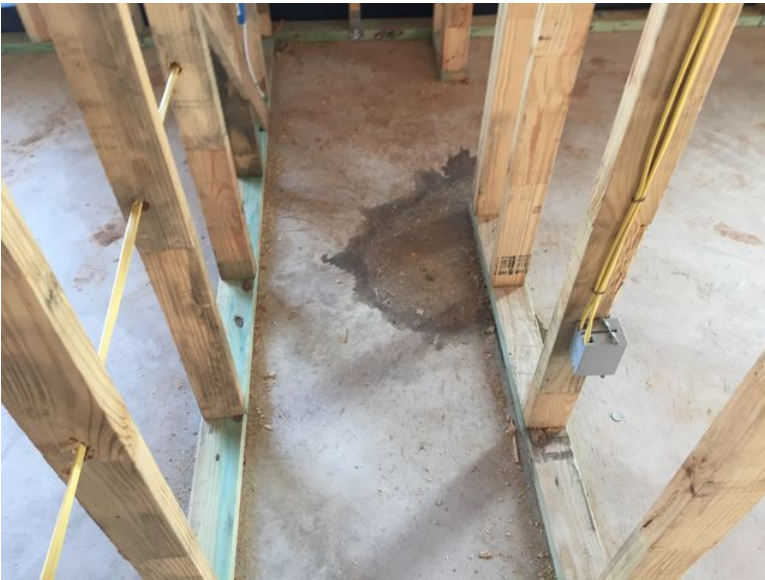
4. It is noted there is moisture noted in one of the secondary bedrooms.
- Find out if there was any other issue.

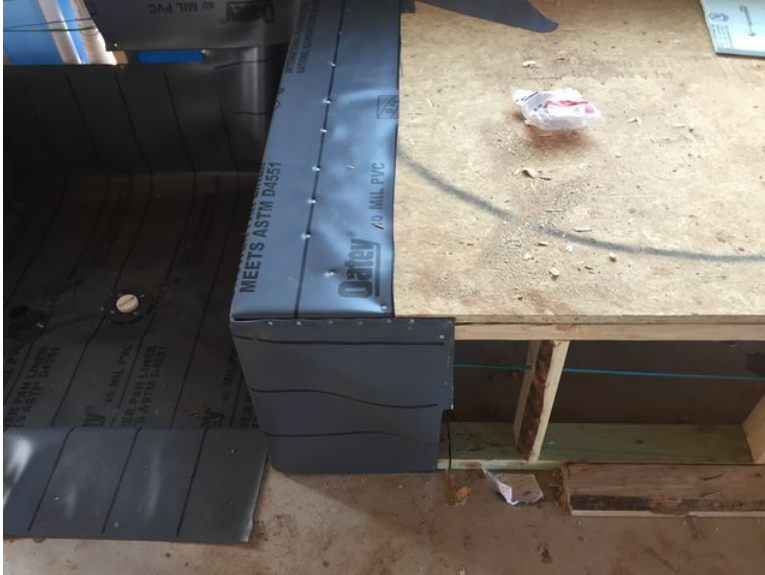
1. PEX pipes are present.
2. The master tub is missing the plumbing lines.

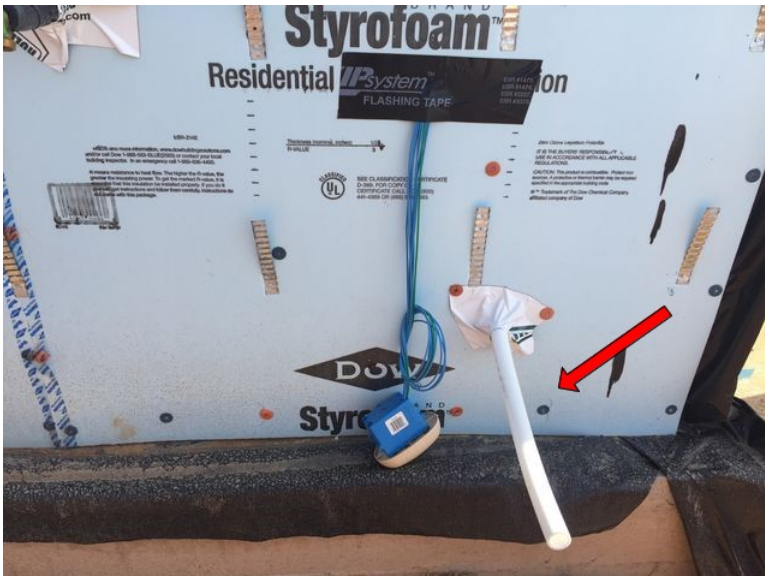
3. The water line has not been connected to the utility line. This means the plumbing lines cannot be pressurized, so it has not been tested as it should be prior to drywall installation.

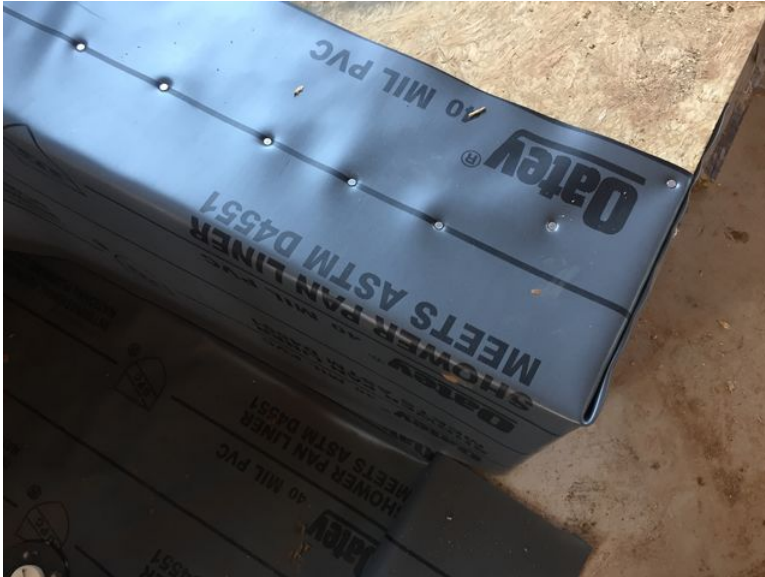
4. Check the master shower liner after the tub lines are installed.

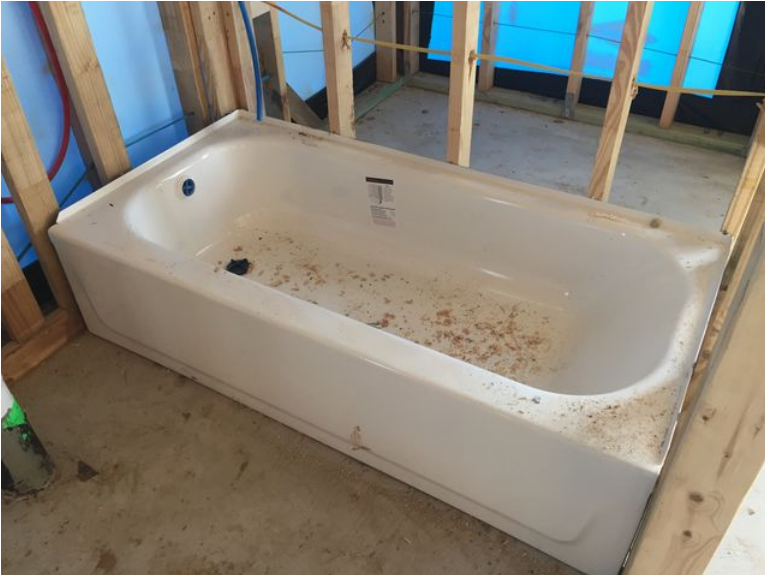
5. A plywood cover should be installed over the porcelain coated steel tub to protect it from construction debris.

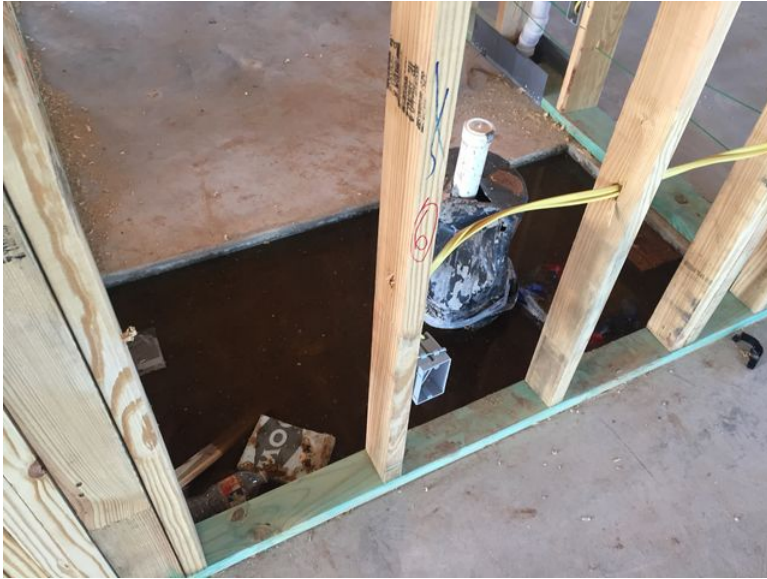
6. Drain the water from the sunken shower pan.

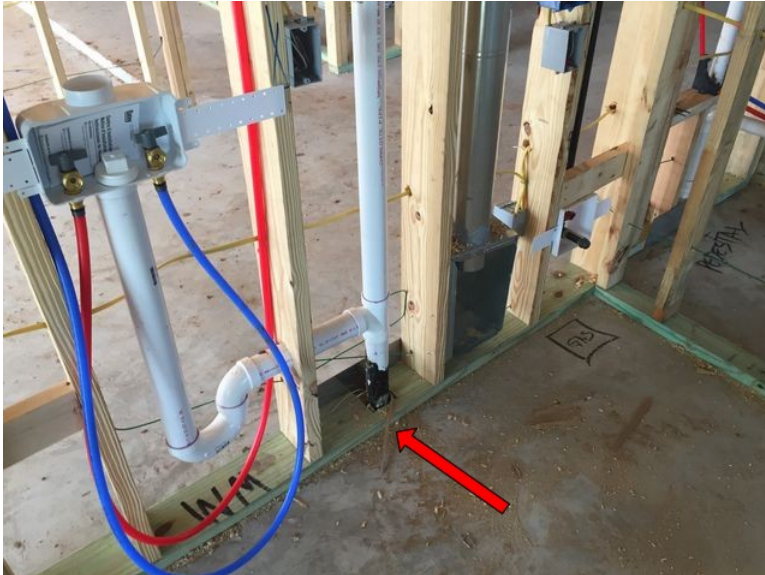
7. Drain lines are missing nail protector plates.

- This is in a few different drain lines.

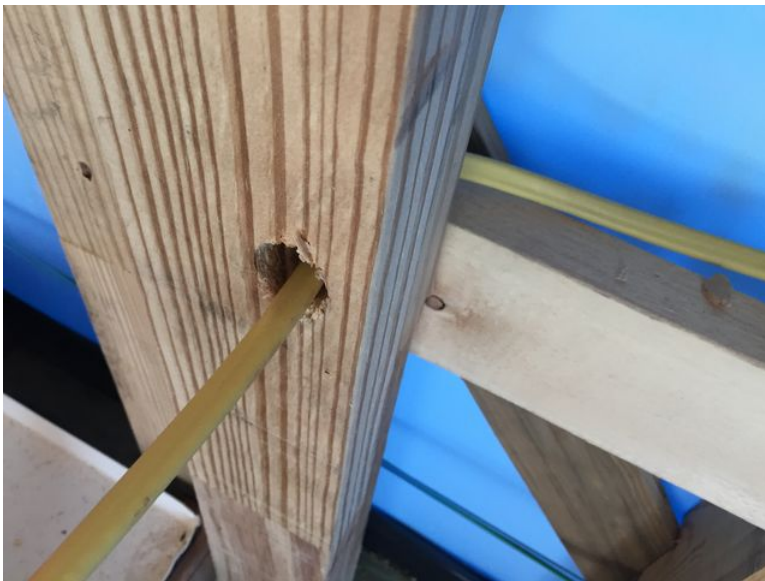
1. Discuss with the builder the locations of the light fixtures in bathrooms. Typically, there are lights above the tubs and showers.
2. There are nail plates that are missing. If electrical lines are too close to the edge of the stud, a metal nail plate should be installed to protect the wires from being damaged by drywall nails/screws.

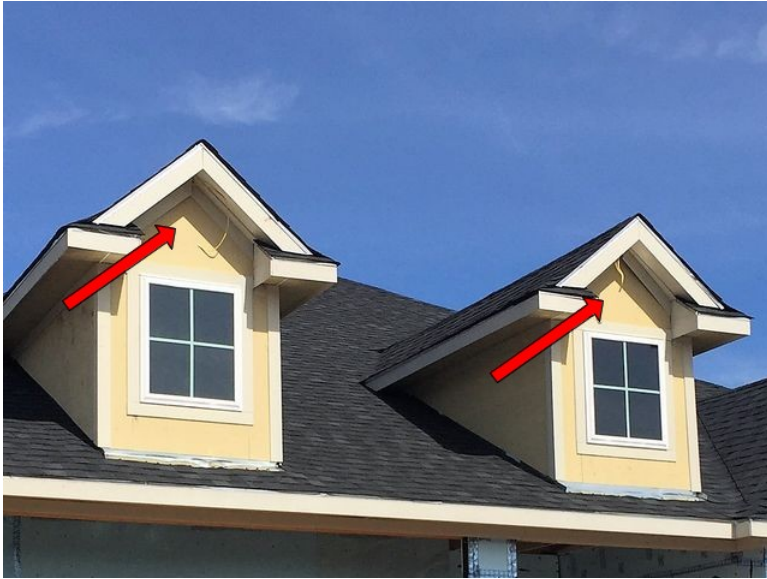
3. The wires in the dormers need to be installed in junction boxes.
