PROPERTY INSPECTION REPORT

Concerning: 123 Dream Street, Fulshear 77441
(Address or Other Identification of Inspected Property)

By: Jim Mortensen, Lic #TREC License #10257 02/16/2018
(Name and License Number of Inspector) (Date)

Report Identification: Sample Recent Construction, 123 Dream Street, Fulshear,

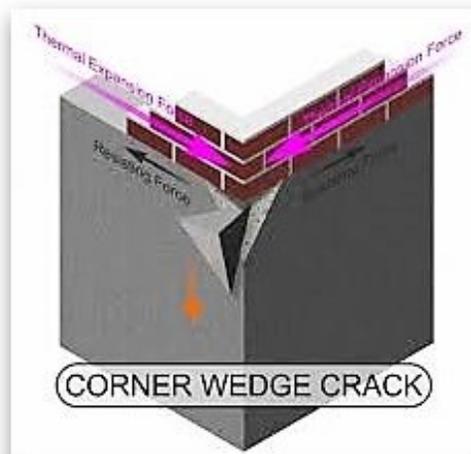
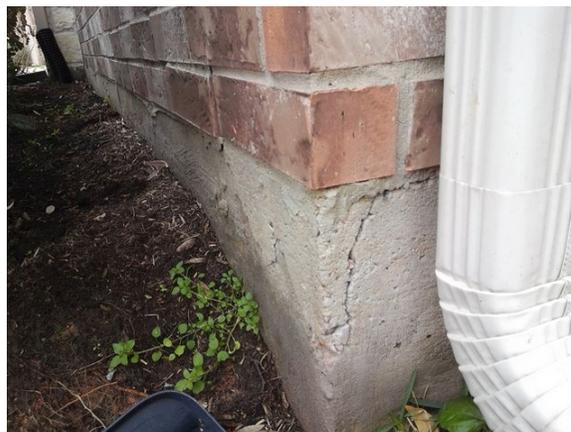
1. The foundation appears to be functioning according to its design.
2. Remember that proper maintenance of the foundation includes maintaining the moisture content of the ground that supports the foundation. Too much water is equally damaging as not enough water.
3. The crack on the corner of the foundation is often called a "shovel crack", "corner crack" or "corner wedge crack" and is very common with a post-tension slab foundation. There are steel cables that run from the front to the back of the house and from side to side of the house. After the concrete is poured, the cables are tightened to 14 tons of pressure to give the foundation rigidity and strength. The force often causes the corner of the slab to crack. For this reason, these cracks are sometimes called "corner cracks".

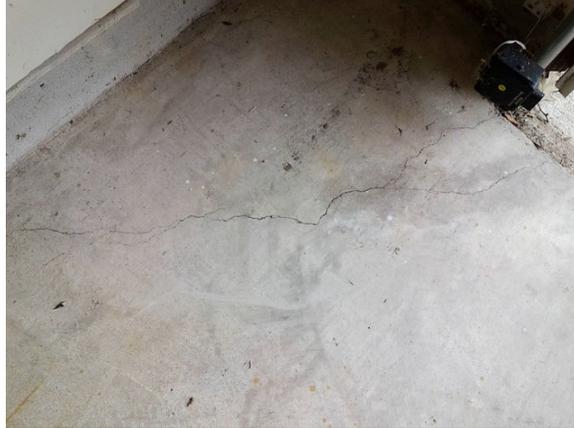
4. Cracks are visible in the exposed concrete slab. It is a common occurrence. These cracks are called shrinkage cracks, curing cracks, or hydration fissures. These cracks are a normally occurring side effect of how concrete cures. While they are normal, these cracks

should be monitored for movement. If the crack widens, or if there is horizontal displacement, a structural engineer may need to evaluate the slab.

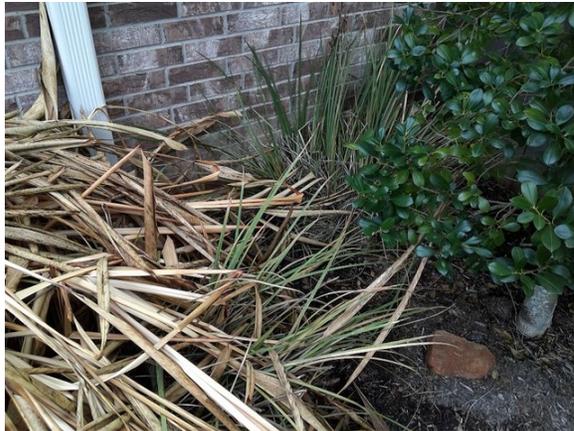
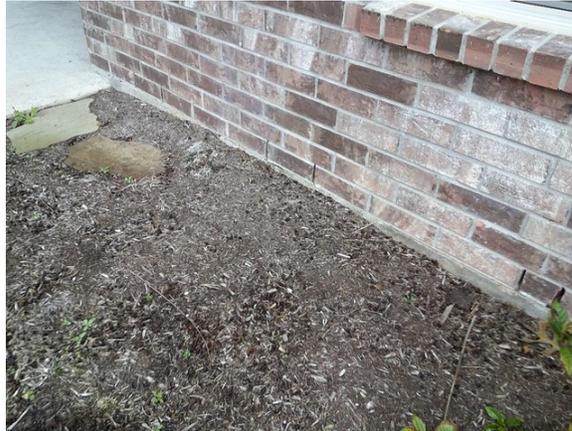
1. High soil is visible in a few areas around the house. There should be four to six inches of exposed slab beneath the bricks. The lack of the exposed concrete makes it difficult to detect wood destroying insects and other insects.

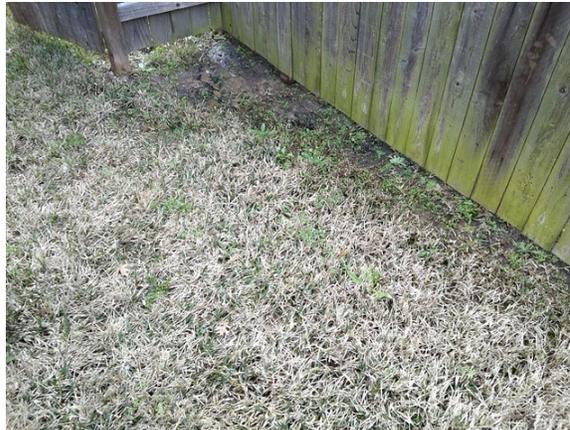
2. This lot is drained with a shallow ditch called a swale. In the backyard, the ground is sloped away from the house and away from the fence. These slopes form the shallow ditch. This swale is supposed to surround the house on the back and carry water away from the house, down the sides of the house to the street where it goes into the storm sewer.
 - There were a couple of areas in the swale that were low and were holding water.

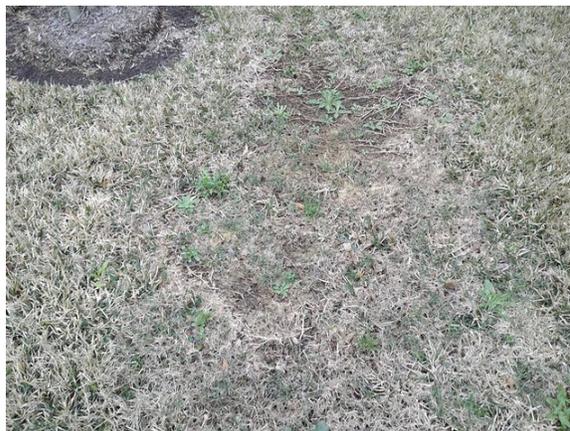
3. Poor grass growth is noted on the lot. This can be caused by several factors including lack of sunlight, lack of moisture, too much moisture, erosion, heavy traffic, and poor soil chemistry (amongst other causes). Determine the cause of the poor grass growth, and then treat the yard with the appropriate treatment.

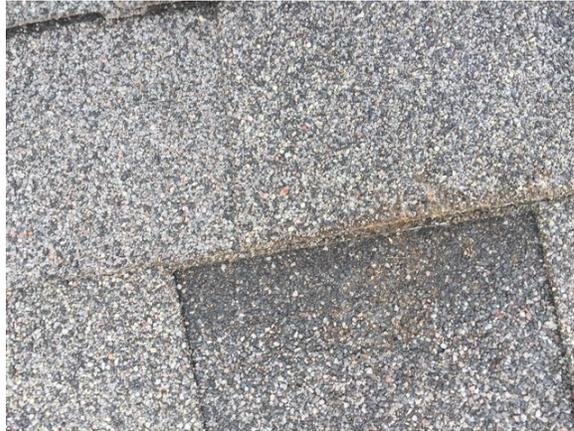
1. There are a few shingles that are damaged. The granules appear to have been knocked off, but damage does not appear to have gone through into the asphalt layer. This is typical of excessive foot traffic or walking on hot shingles (softer asphalt).

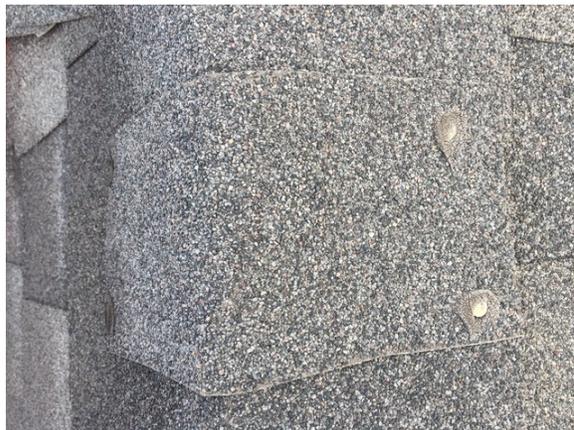
2. There are nail heads that need to be sealed with roofing cement. This comes in tubes and can be applied with a caulk gun.

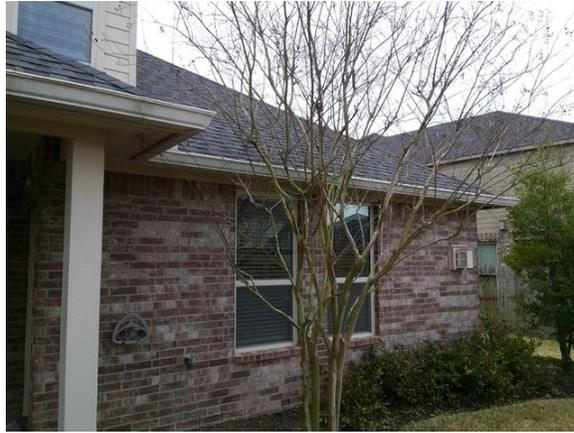
3. The tree branches are too close to the house. If tree branches contact the shingles, they can cause damage. Trim the tree branches as part of normal homeowner maintenance.

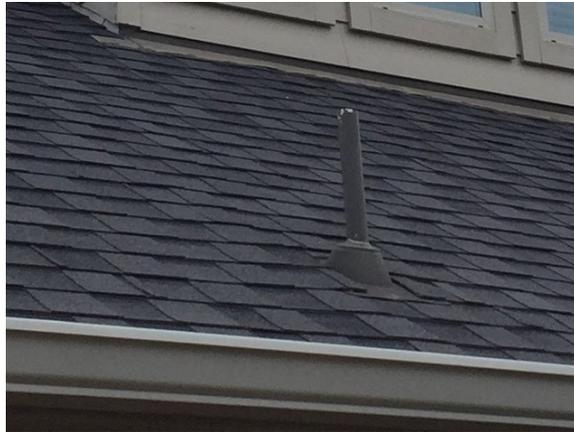
4. As part of normal homeowner maintenance, the roof plumbing vents need to be caulked and painted. Monitor these areas to make sure the rubber gaskets are consistently protected from damaging UV light.

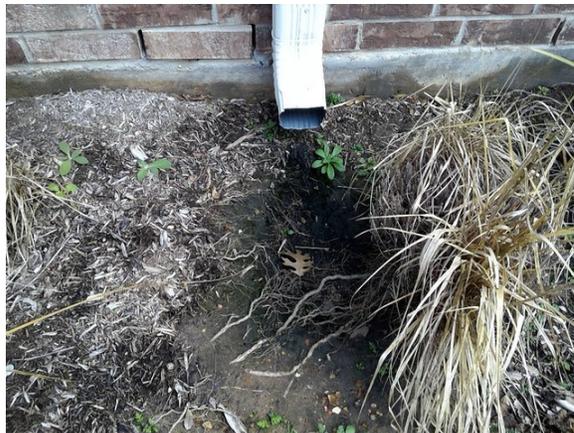
5. Splash blocks are missing from beneath the gutter downspouts. This will help prevent erosion and direct water away from the foundation.

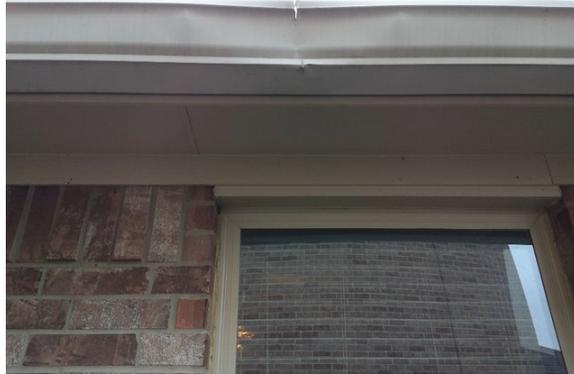
6. The gutters have damage on the right side of the roof line.

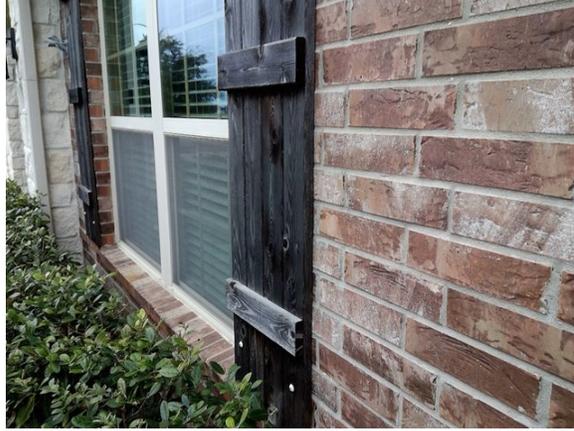
1. The exterior of the house is brick veneer, stone veneer and cement fiberboard siding with cement fiberboard trim.
2. The exterior of the house needs to be cleaned with a product like "Jomax". This is used in a low-pressure sprayer. Avoid using a high-pressure washer that damages paint and material. This product is available at most home improvement stores in the painting section. It will clean the mildew that grows on the exterior of the house.
 - For more information, visit the following website: <http://www.rustoleum.com/product-catalog/consumer-brands/jomax/jomax-house-cleaner-and-mildew-killer>
 - This typically needs to be done periodically. .
3. The faux shutters are starting to fade. They need to be refinished. Because they are wood,

they need to be sanded, stained and then sealed. Sanding preps the surface, stain provides protection against the UV light from the sun and sealant (varnish) protects against moisture damage.

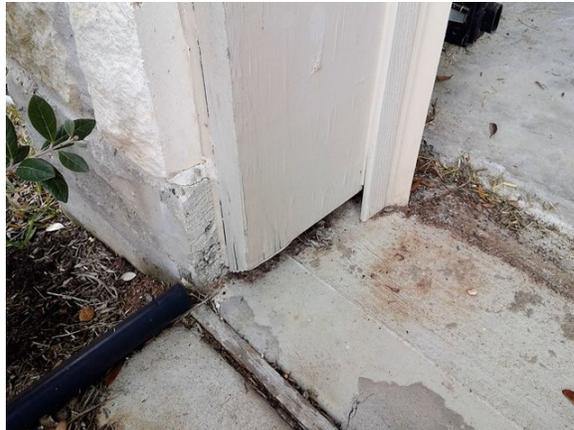
4. The trim on the garage needs to be painted. The bevelled area needs to be painted so water cannot penetrate the wood grain and cause the area to rot.

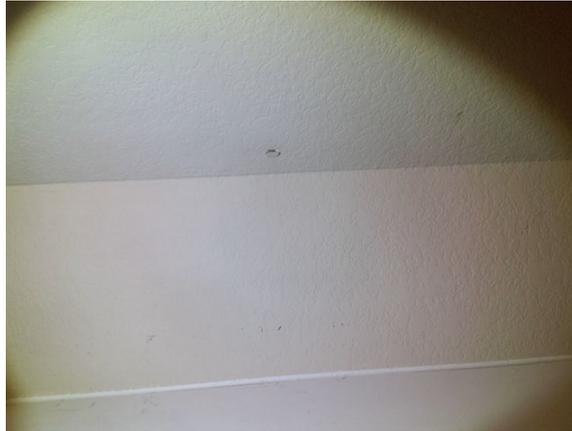
- Noted in camera feed closet.

5. There are various drywall imperfections in the house that are typical of a house of this age. These include visible drywall seams, previous repairs, nail pops, settling cracks and normal wear and tear.

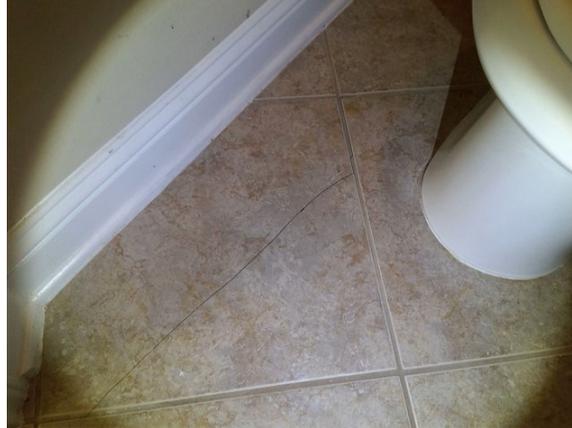
4. Cracked tiles noted in the master water closet.

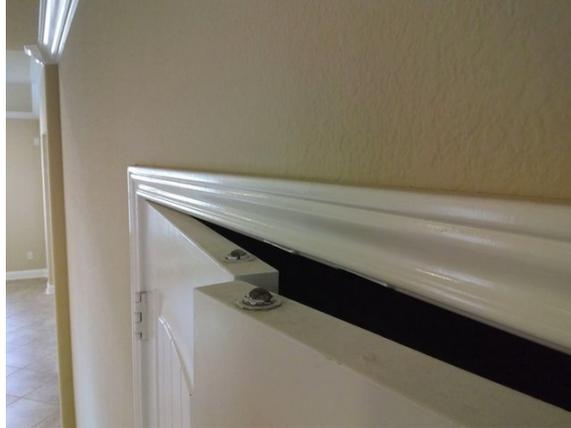
- The double door hardware needs to be lubricated as part of normal homeowner maintenance. These doors are closed and held in place with friction from a piece of hardware. This spring-loaded ball holds the door in place due to friction against the door catch at the top of the door jamb. If the ball pops loose, the door will not stay closed. This threaded insert can move if there is friction on this area. Proper maintenance is needed to avoid this. Spray silicon lubricant on these areas periodically to minimize this issue.

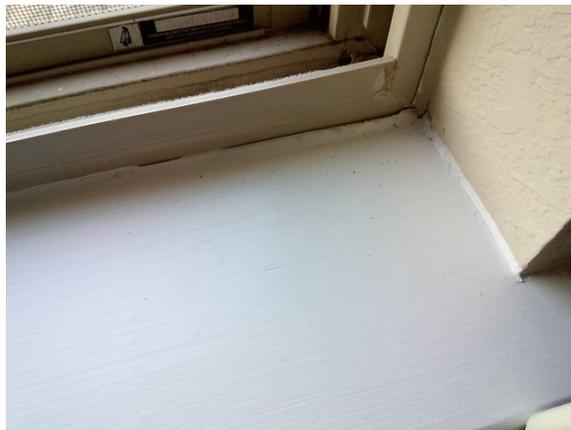
- The window stools need to be caulked to minimize moisture damage (Window sills are on the exterior of a house and window stool is on the inside). Remove the loose or cracked caulk and then replace. Any rotten wood or flaking paint on the stool should be repaired or replaced as well.

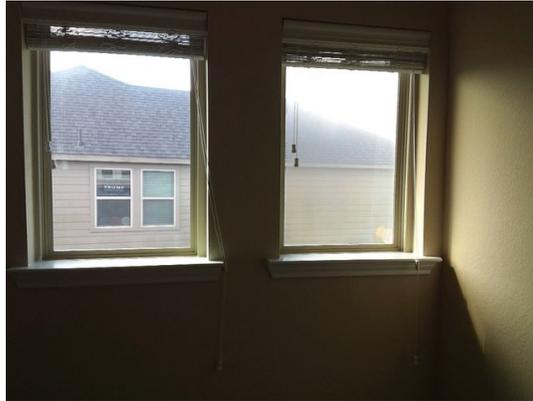
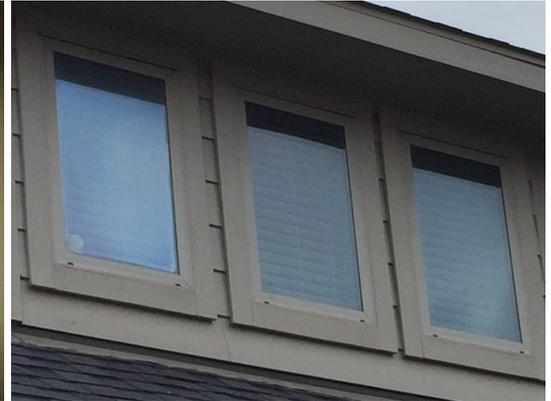
- This house has double pane, low e-square windows. This means the windows have a special coating that reflects heat out of the house. This coating can get contaminated and appear to be a dirty or foggy window, often with a purple hue to it. This is considered a defective window even though the glass is not broken. Contaminated window film noted in the game room.

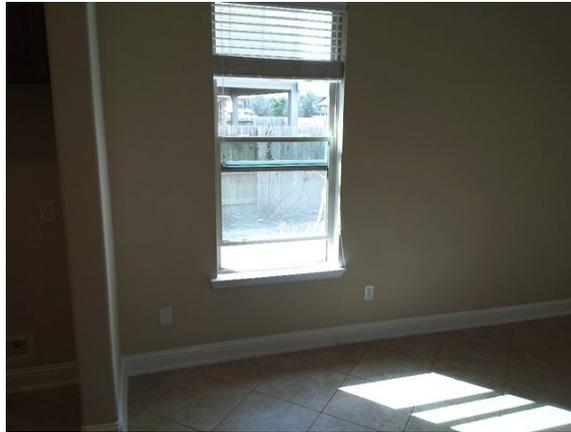
Side living room window, for example.

3. Some of the windows are tight and require more force than necessary to raise.

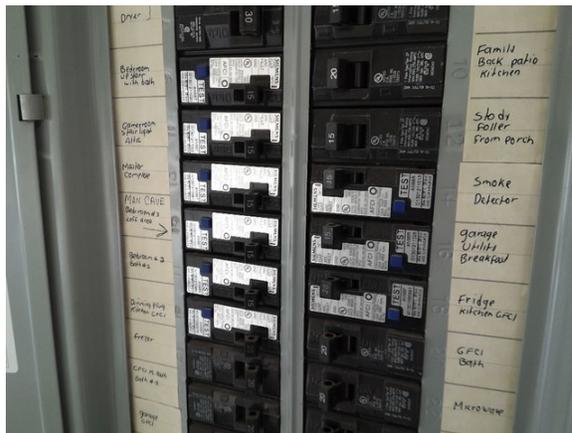
2. Currently required arc-fault protection is missing (AFCI). - The Texas Real Estate Commission (TREC) requires the lack of arc-fault circuit interrupting devices serving family rooms, dining rooms, living rooms, parlors, libraries, dens, bedrooms, sunrooms, recreations rooms, closets, hallways, or similar rooms or areas to be noted as a deficiency. These arc-fault circuit interrupting devices were required in new construction for the first time in 2003 in bedrooms, then more areas in 2009 and then again more areas 2014 (including a combination AFCI and ground fault circuit interrupter protection). Before this time, it was not required to have these devices installed on the house. It usually is not realistic to expect a buyer to upgrade their electrical panel to current requirements. An arc-fault breaker is designed to detect when electricity does not flow properly and circumstances that can lead to an electrical fire.

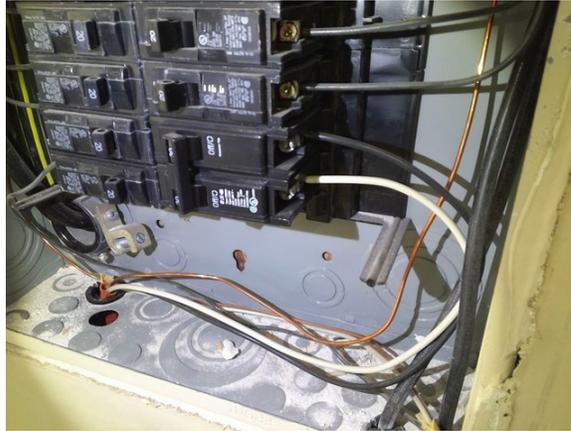
3. The white wire on the shared 220 Volt circuit should be marked to indicate it is being used as a "hot" wire and not a neutral. White wires are designated for use as a neutral wire, but if used otherwise should be marked (black electrical tape or colored black with marker) so that

if removed from the breaker, there is no doubt what it is used for.

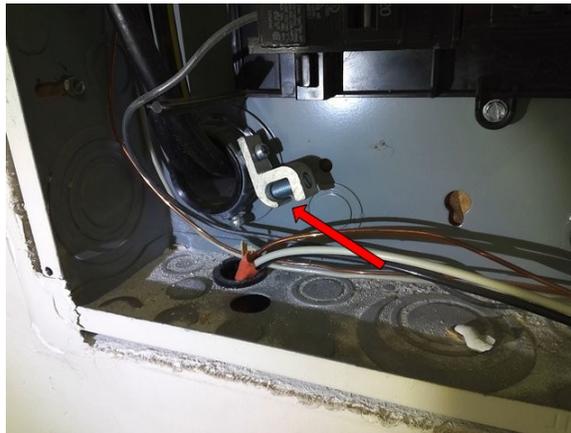
4. Ground wire lug in electrical panel is not used.

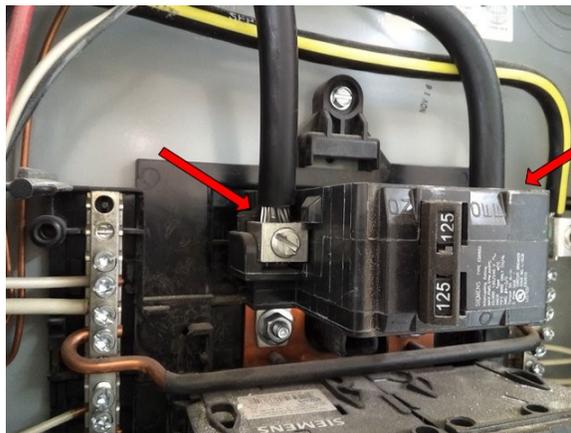
5. The service terminals should have anti-oxidant paste. These wires are aluminum and can oxidize. When aluminum is used to bring electricity to the house it is okay. Branch circuit wiring is copper: does not have aluminum wire issues.

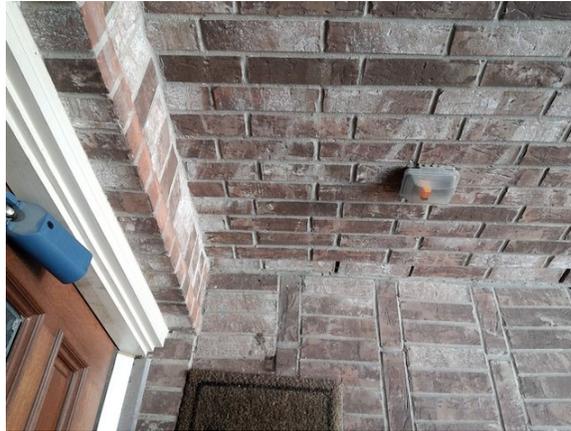
- A ground fault circuit interrupter (GFCI) is a device that can detect when electricity is not flowing properly. When this happens, it will interrupt the power flow to the outlet. It is required for all wet areas, including exterior outlets, garages, bathrooms, kitchen counter tops and islands.
- New electrical codes now require GFCI protection for all kitchen appliances. When this house was constructed, this was not a requirement.
- None of the exterior outlets have GFCI protection, but the GFCI reset outlet in the garage functions. This is usually what provides the GFCI protection to the exterior outlets. .

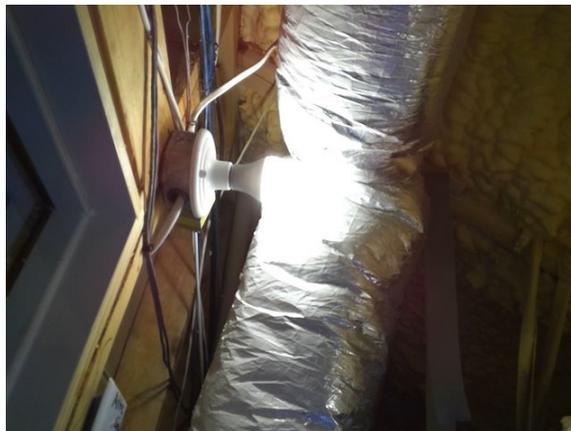
2. The light in the closet is very close to the duct. Because this is an LED light, it most likely will not be an issues (overheating or damaging the duct). Monitor this area periodically.

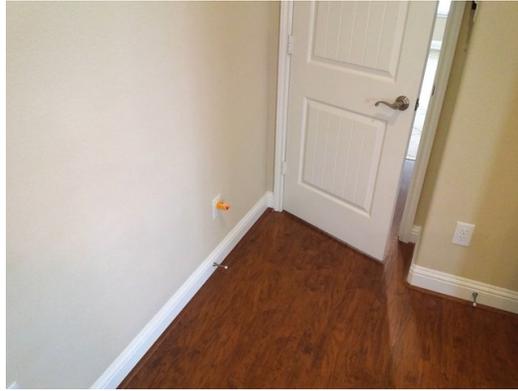
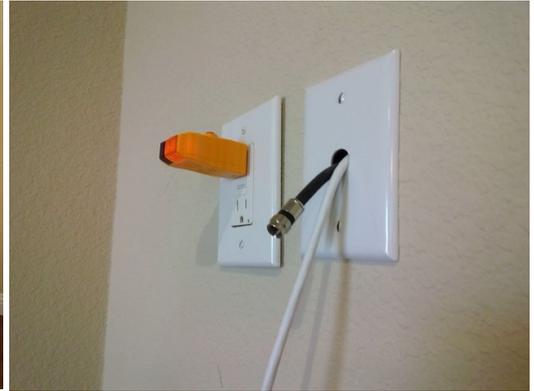
3. There were various loose outlets throughout the house.

Noted in master bedroom, for example. Also, the right picture shows a GFCI outlet that is not needed in this location.

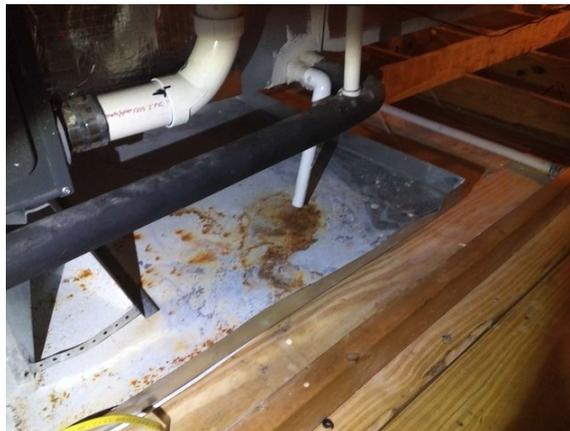
- Rust is noted in the safety pan.

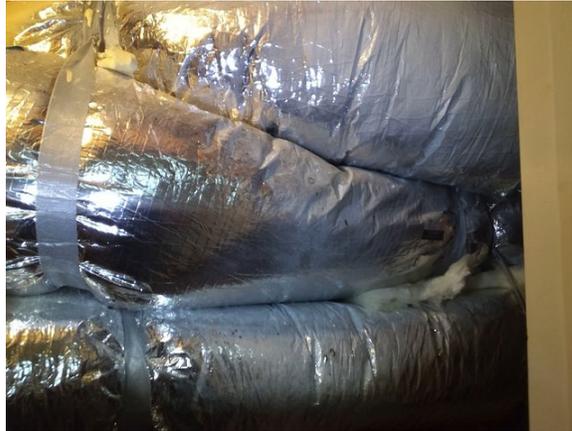
2. Place insulation between the ducts to reduce condensation that forms when ducts are in contact with each other.

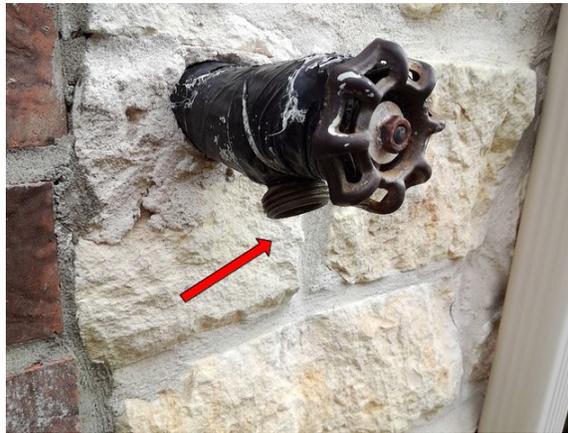
1. The plumbing supply lines in this house are PEX (cross linked polyethylene).
2. One of the anti-siphon devices is missing from the exterior hose bibs.
 - An anti-siphon device is designed to protect the home drinking water supply from contaminants. Hose bibs, dishwashers, sprinkler system and pool supply lines are required to have them.

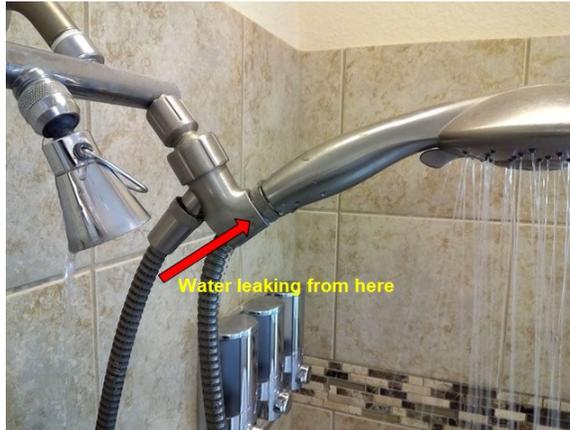
5. Master bath shower head leaks.

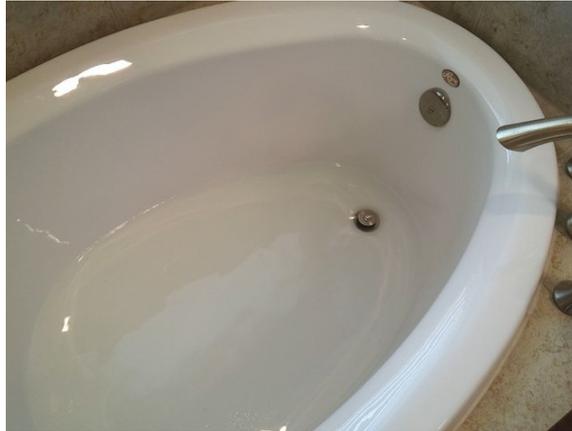
- Slow drain noted in the master tub and the hall bath tub.

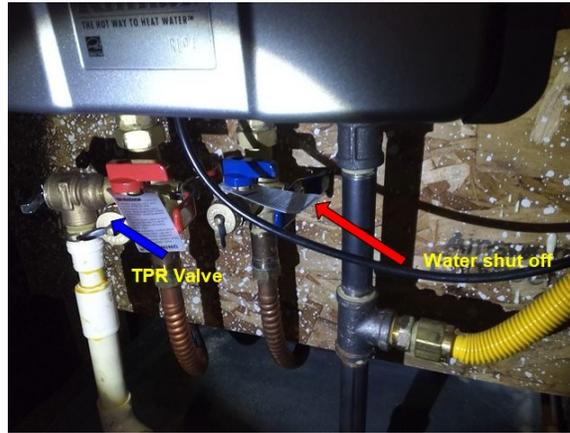
2. The cold water supply to the water heater is shut off.

- Noted in the blue arrow in the previous photo.
- This valve should be checked as part of a home inspection. This test cannot be performed, however, because of the hard water conditions in the Houston area. If the valve is opened, the hard water deposits present will cause the valve to stay open. It often has to be replaced. Since no destructive testing can be done as part of a home inspection, this part of the water heater is observed only. There were no visible issues noted with the valve itself.

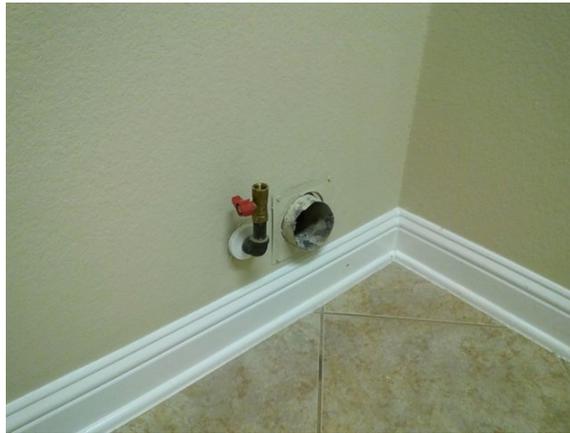
4. Leak detectors are recommended to minimize any water damage in the event of a leak. These can be placed in the utility room, attic space (by water heater) and in the kitchen. There are different models available that have audible alerts, can send alerts to smart phones through a wi-fi component or can be attached to a servo that will shut off a pipe. Discuss with a plumber or home automation expert the pros and cons of the different systems to find out which is best.
5. A gas cap is needed for the clothes dryer gas line.

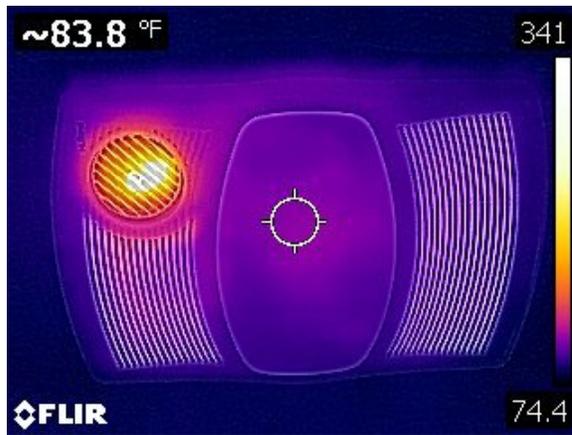
2. When measured with an infrared thermometer, the heater was degrees 282 Fahrenheit.

Infrared indicates the hottest point is 341 degrees. Use caution with this appliance. Read the owner's manual for any specific safety instructions.
