PROPERTY INSPECTION REPORT

Concerning: 123 Dream Street, Fulshear 77441
(Address or Other Identification of Inspected Property)

By: Jim Mortensen, Lic #TREC License #10257 02/16/2018
(Name and License Number of Inspector) (Date)

Report Identification: Sample Recent Construction, 123 Dream Street, Fulshear,

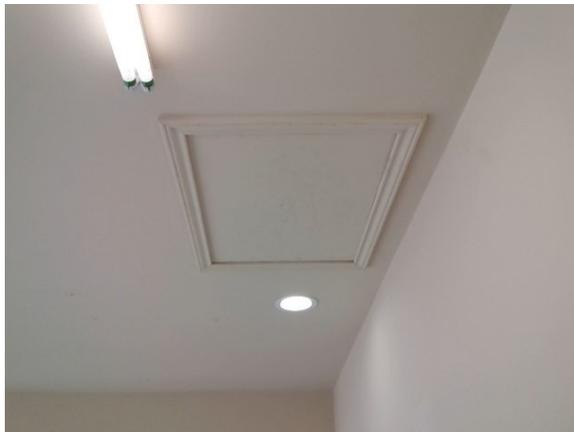
1. The attic insulation is polyurethane foam insulation.
2. This house was designed with the building envelope going all the way to the roof and including the attic. Most houses are built where the building envelope does not include the attic and stops at the ceiling of the second floor. This is significant because it means the house should not have a ventilated roof.
3. The unconditioned attic space above the garage has soffit vents, but needs a roof vent to allow the soffit vents to function properly.
4. The attic has three different areas that are accessible. :
 - One is above the garage and is accessed through a scuttle hole.

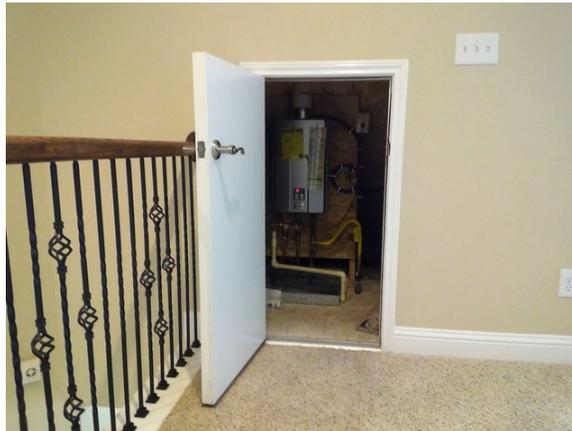
- There is an attic space on the left side of the upstairs game room, which is accessed through a small door. This area houses the water heater.

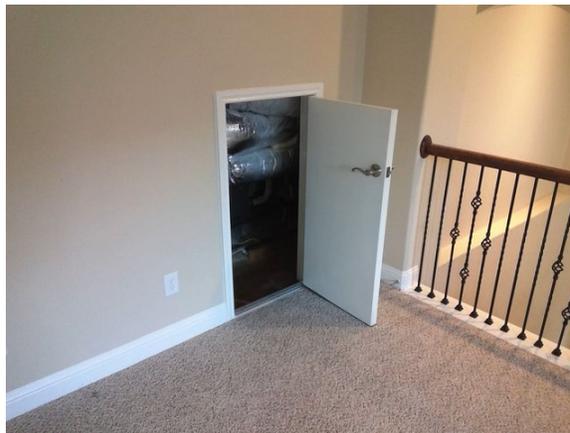
- The last area is on the right side of the game room. It is also accessed through a small door, but this contains the HVAC system of the house.

Due to the mechanical systems of the house, there is limited access to the attic areas. There is no decking (which is typical) so use caution when going in this area.

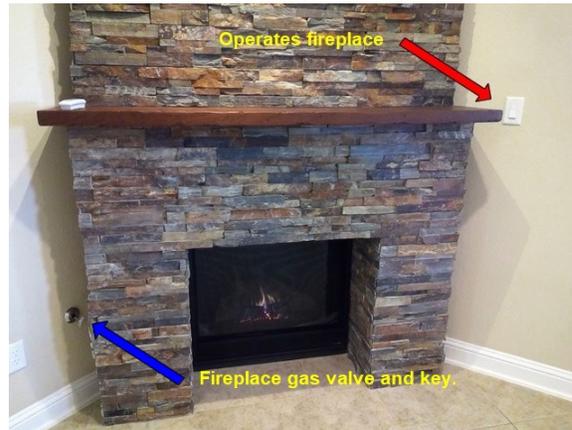
1. The direct vent fireplace is not a traditional fireplace. It is a metal fireplace that burns gas through ceramic logs. It does not have a damper or any readily accessible parts. It is essentially a decorative furnace behind glass. This particular model operates with a wall switch.

2. Note the gas valve with the key to the left side of the fireplace.

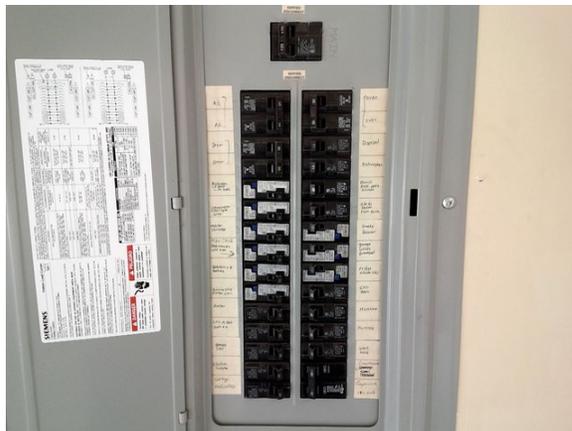
1. One hundred and twenty-five Amp service noted in the main panel.

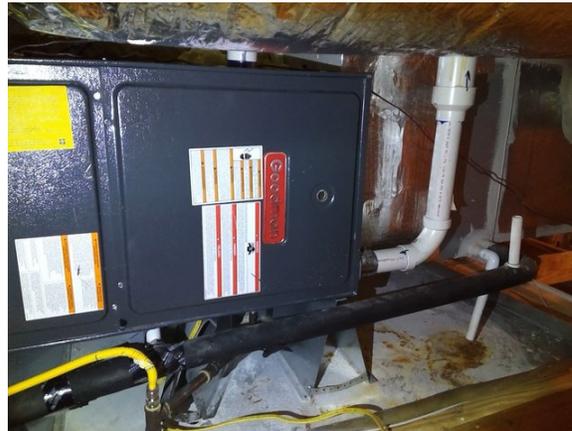
1. It is recommended to service the furnace equipment every fall to make sure it is operation and perform any preventative maintenance required. Doing so will maximize the lifespan of the equipment and is considered part of proper homeowner maintenance.
 2. The furnace started without any incident. The standards and practices of the industry are to remove the cover and observe the flame pattern of the burner at the heat exchanger. This particular model is a 90-95% efficient unit. It has a second heat exchanger and neither of them is visible. Therefore, the flame pattern could only view the flame through a small window.
- It removes enough heat from the combustion process to use PVC pipes to vent the exhaust gases to the exterior of the house.

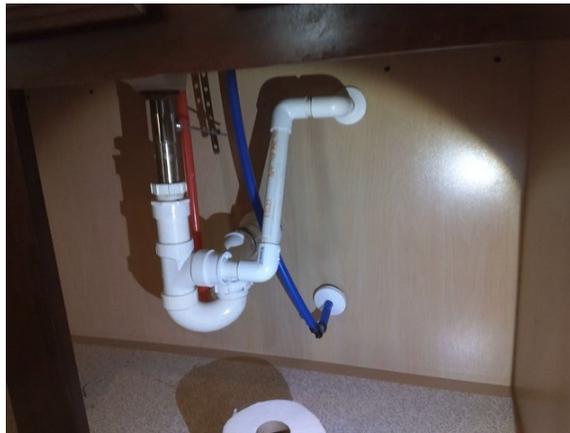
The primary condensate drain line starts in the attic by the AC unit. It then connects to the plumbing drain lines under the master bathroom sink.

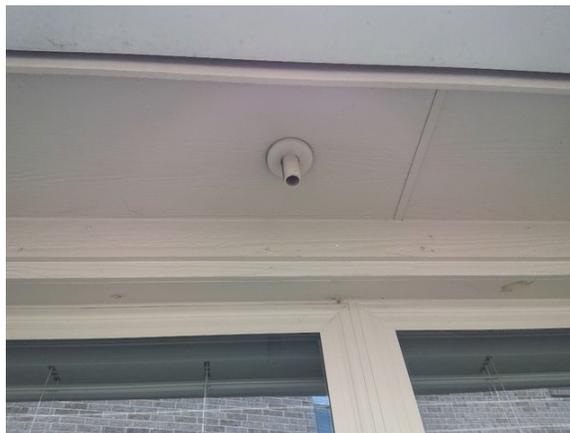
The pipe on the exterior of the house that is raised above the first floor is called the secondary or emergency condensate drain line. If water is flowing out of this pipe, there is a problem with the primary condensate drain line.

Having the system serviced once a year will lessen the risk of water over flowing and causing damage to the interior of the house.

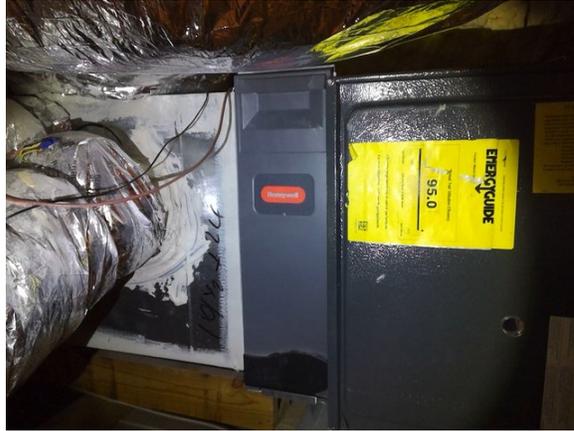
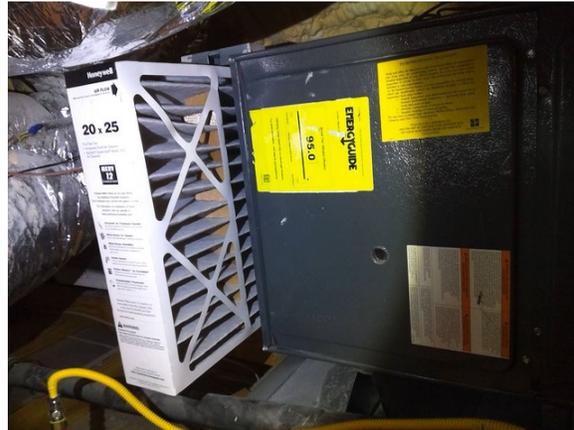
1. The filter installed in this system is known as a media filter. It is four inches thick and has pleated filter material inside it. It should be checked every 3 months, but typically only needs to be replaced every six months to a year. It depends on the lifestyle and cleaning habits of the occupants.

2. Place insulation between the ducts to reduce condensation that forms when ducts are in contact with each other.

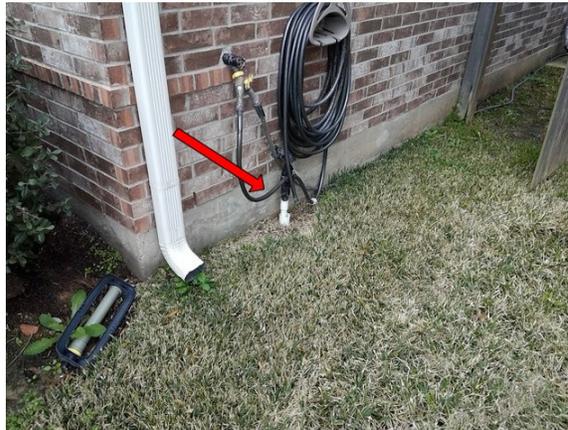
3. Main water shut off noted below.

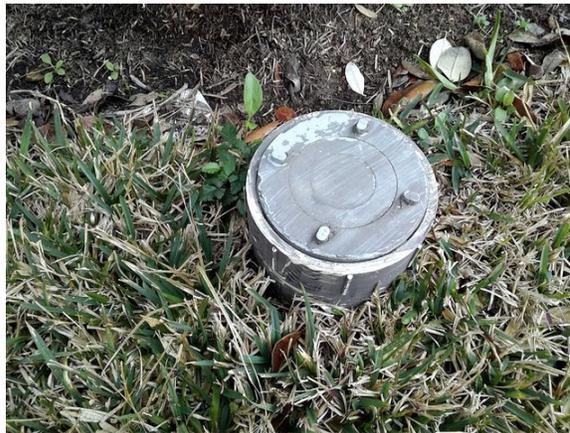
2. A sewer clean-out cap with a relief valve has been installed. This may allow an escape for sewage in the event of a stopped-up line.

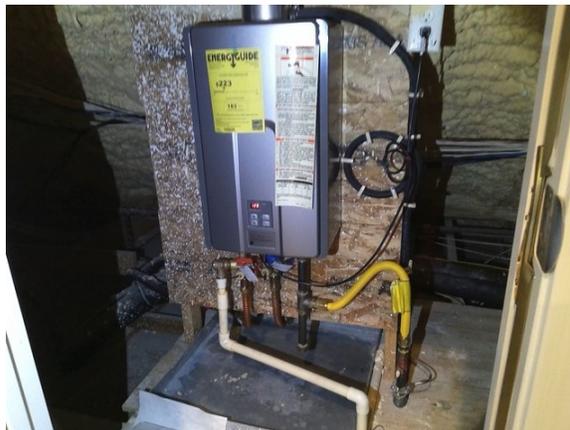
- 1, The water heater is located in the attic.

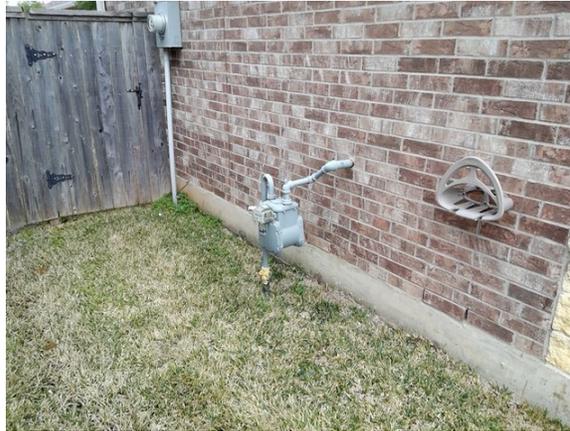
6. The gas meter is located on the left side of the house.

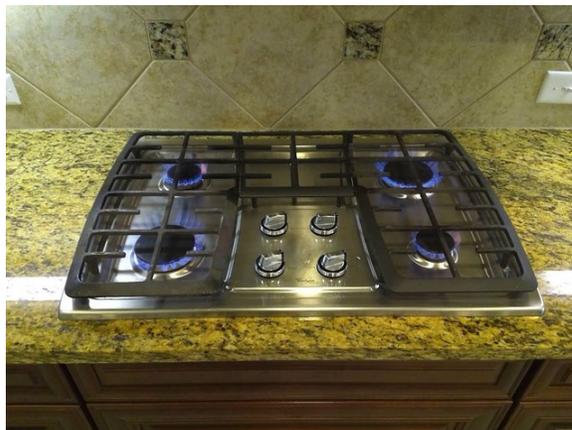
1. The cook top is a gas appliance.

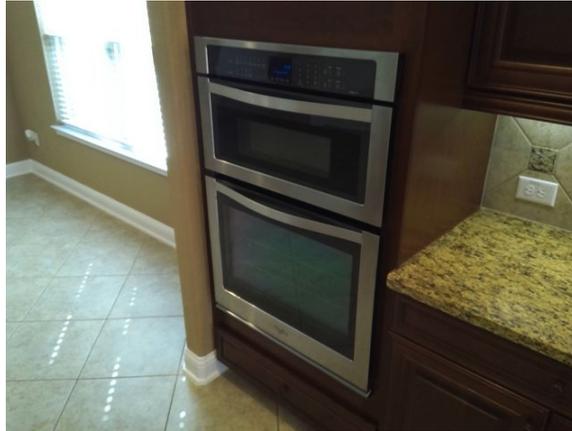
3. Oven accuracy is tested by setting the thermostat to 350 degrees and then measuring the temperatures. Acceptable temperatures fall between the range of 325 and 375.
 - The upper is a microwave oven. .
 - The lower oven reached 330 degrees Fahrenheit.

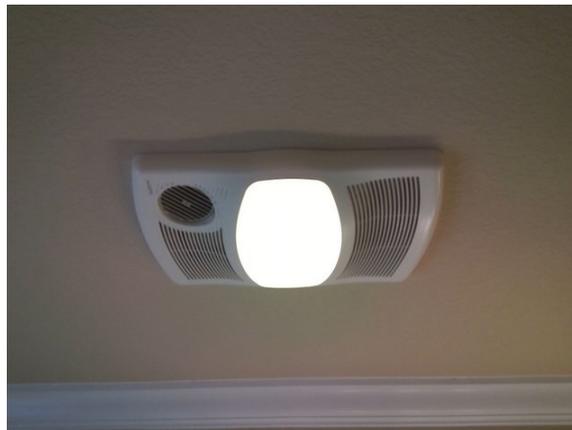
1. This house contains a fan/light/heater unit not found in most modern construction houses.

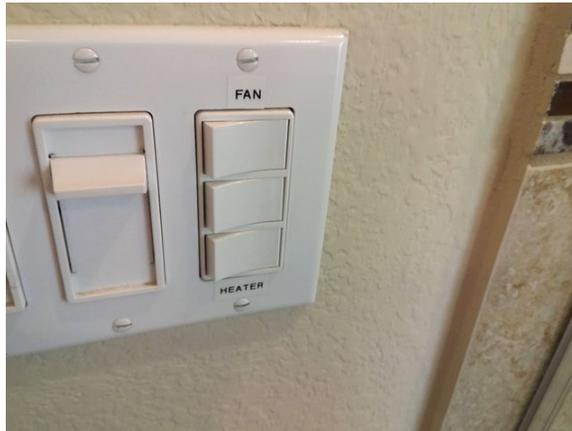
2. When measured with an infrared thermometer, the heater was degrees 282 Fahrenheit.
